3. Existing Conditions & Analysis

This chapter contains descriptions and analysis of a variety of existing conditions found throughout the Highway 23 / Grand Avenue corridor. Issues related to safety, operations, and level of service (LOS) were looked at with respect to the different modes of transportation and the impacts of potential changes in land use patterns and future traffic volumes.

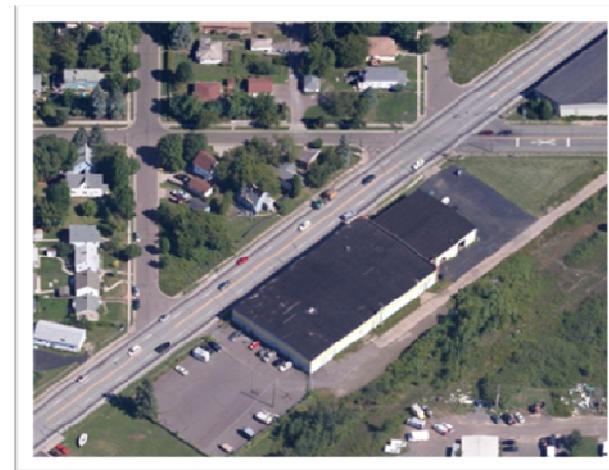
Figure 3.1 | Urban section of Highway 23

The area around the five-legged intersection of Raleigh Avenue represents an urban section of the Highway 23 / Grand Avenue corridor where issues related to turning movements at acute-angle intersections are more prevalent than in the corridor's more rural sections.

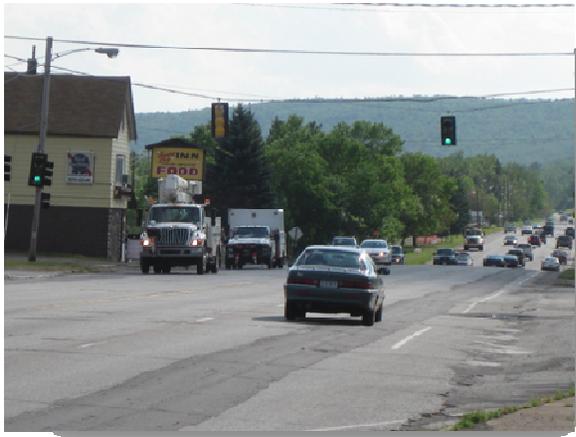
Figure 3.2 | Traffic on Highway 23 / Grand Avenue

The wide roadway, limited signalization, and heavy traffic patterns found on Highway 23 have the potential to create barriers to access, especially for non-motorized users trying to cross the highway.

In addition, Highway 23 serves as an important regional travel corridor for both daily commuters and heavy trucks hauling freight. As such, the route has been designed as a 4-lane highway to facilitate these movements in addition to local access. But the density of land use and traffic throughout much of the corridor is too low to warrant traffic signalization. This translates into a land use pattern of its own, one which impedes non-motorized movements across the roadway and in a sense separates uses on the northern side of the corridor from activities on the southern side (Figure 3.2).

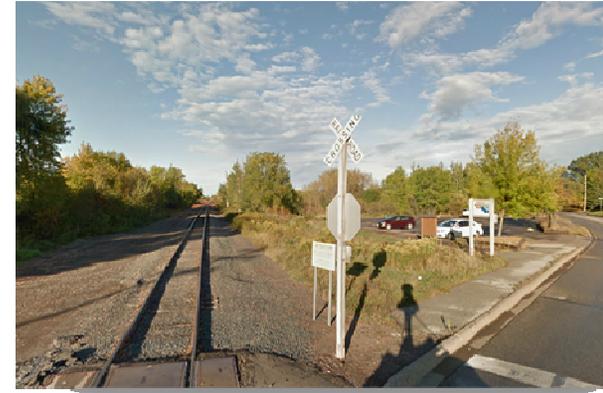
Figure 3.3 | Rail crossing and trail head at Pulaski Street

Rail and trail corridors exist in close proximity to Highway 23, creating opportunities for intermodal connections.

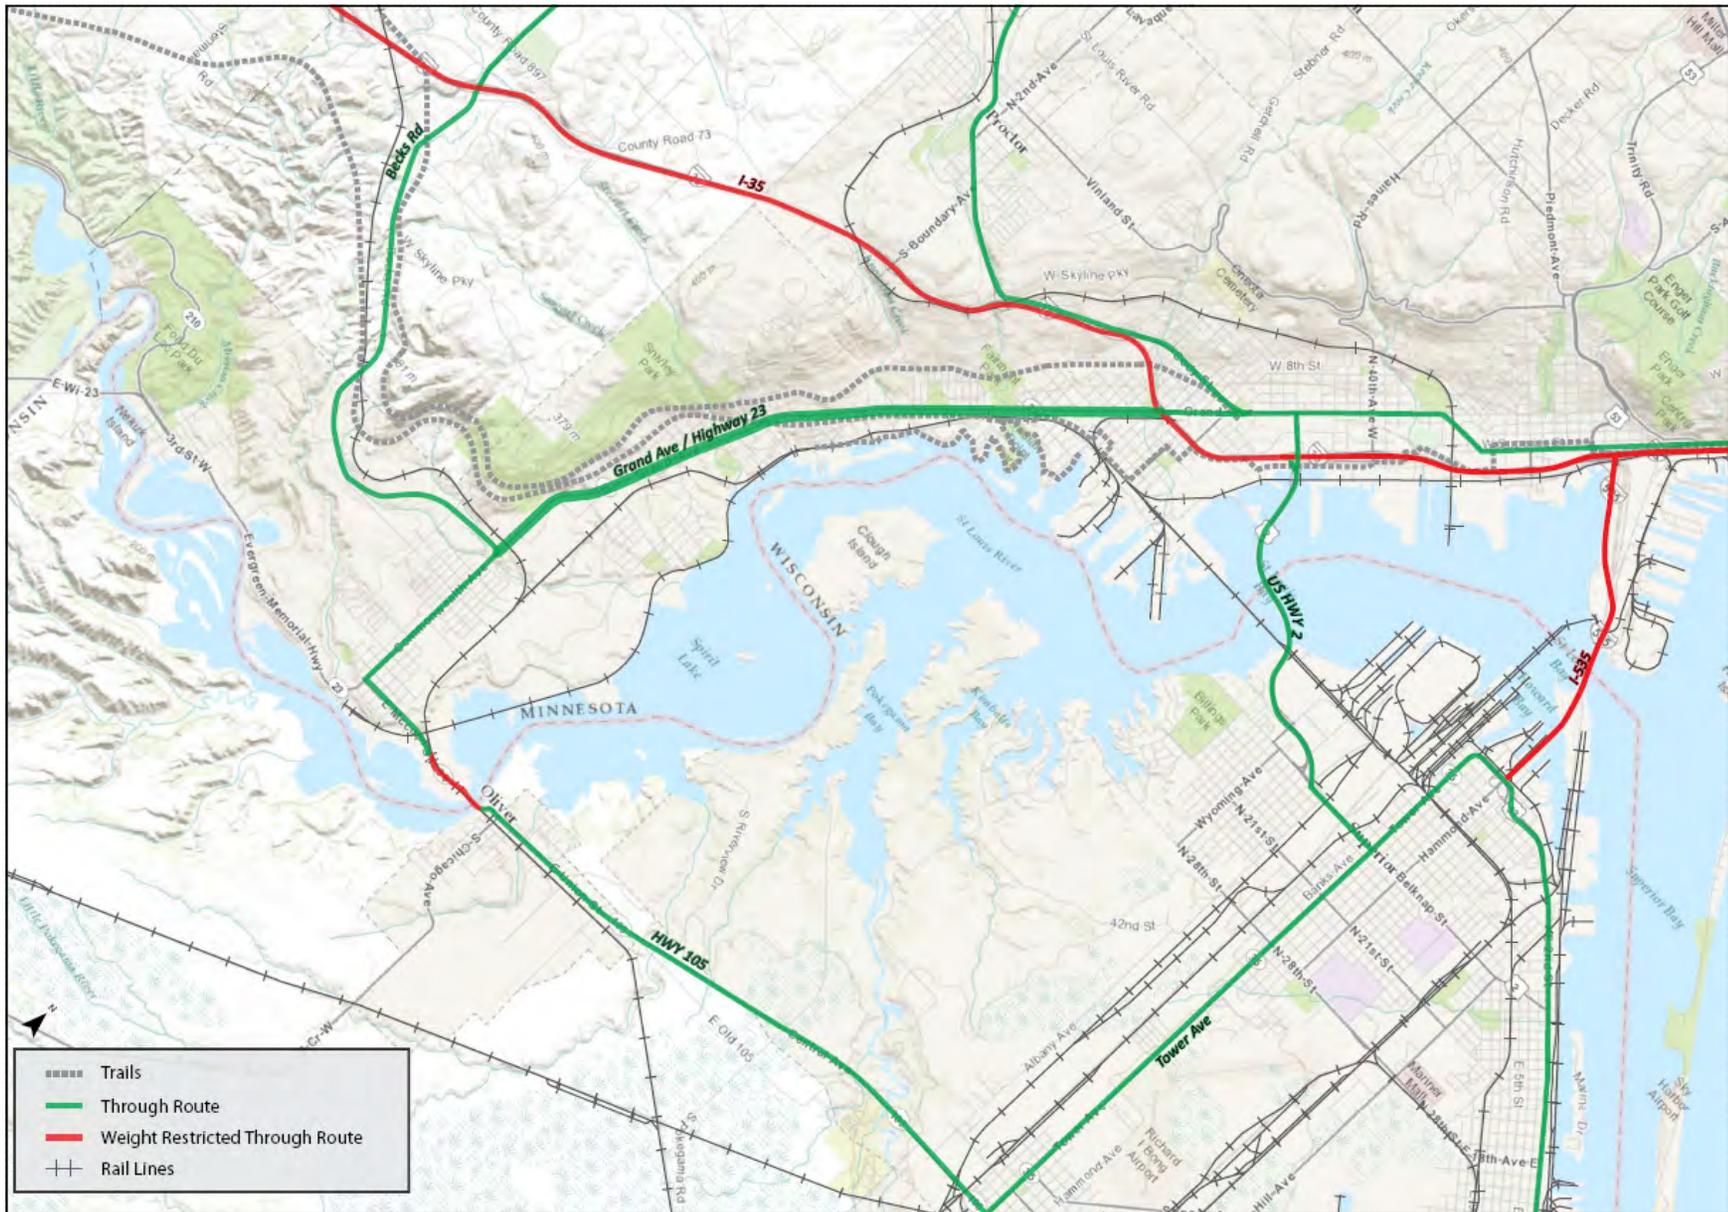
Map 3.1 | Alternative through routes and regional trails

Highway 23 / Grand Avenue is the most direct arterial route that connects land uses southwest of the I-35 interchange. It is also the only route without weight-restrictions for heavy-haul truck trips. Intermodal opportunities also exist between the highway and area railways and trails systems.

Superior) are several miles longer. This is apparent in Map 3.1 on the following page, which shows the regional through routes in green.

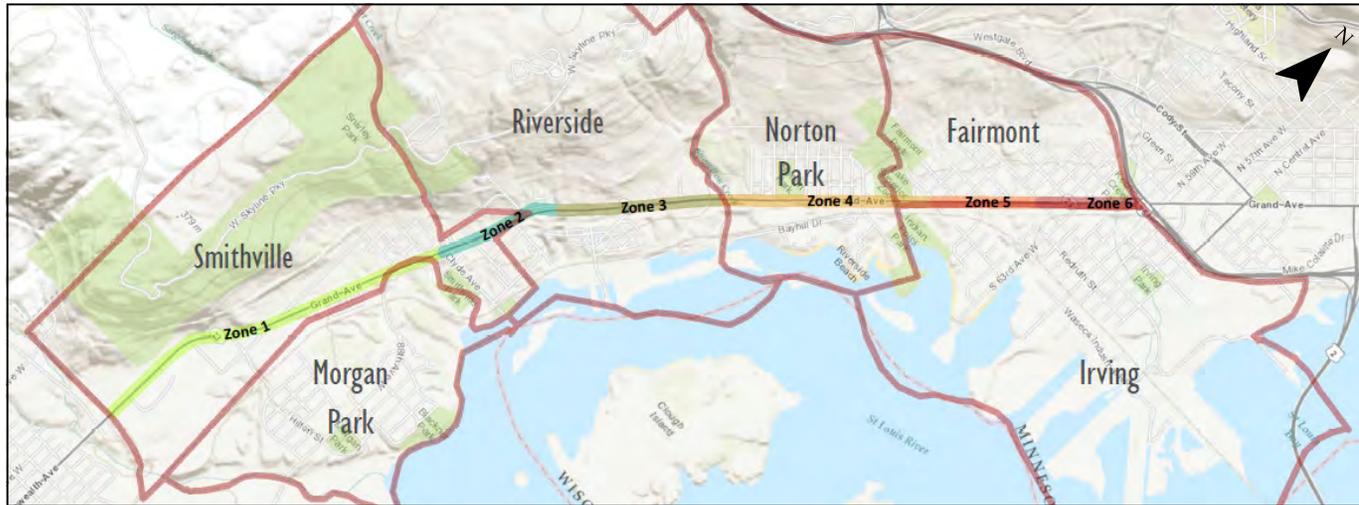
Map 3.2

Highway 23 context zones & West Duluth neighborhoods

This plan identifies six distinct zones where the land use context changes along the roadway. These zones correspond roughly to the locations of the different neighborhoods along the corridor. Data collection and analysis were done according to these zones.

However, the highway is equally as important for local access as it is for through movements. It serves six neighborhoods (Map 3.2, page 25), each with varying degrees of access to the highway and surrounding facilities. Moving forward, it will be just as important to ensure good access to the residences and business along the highway as it will be to ensure capacity.

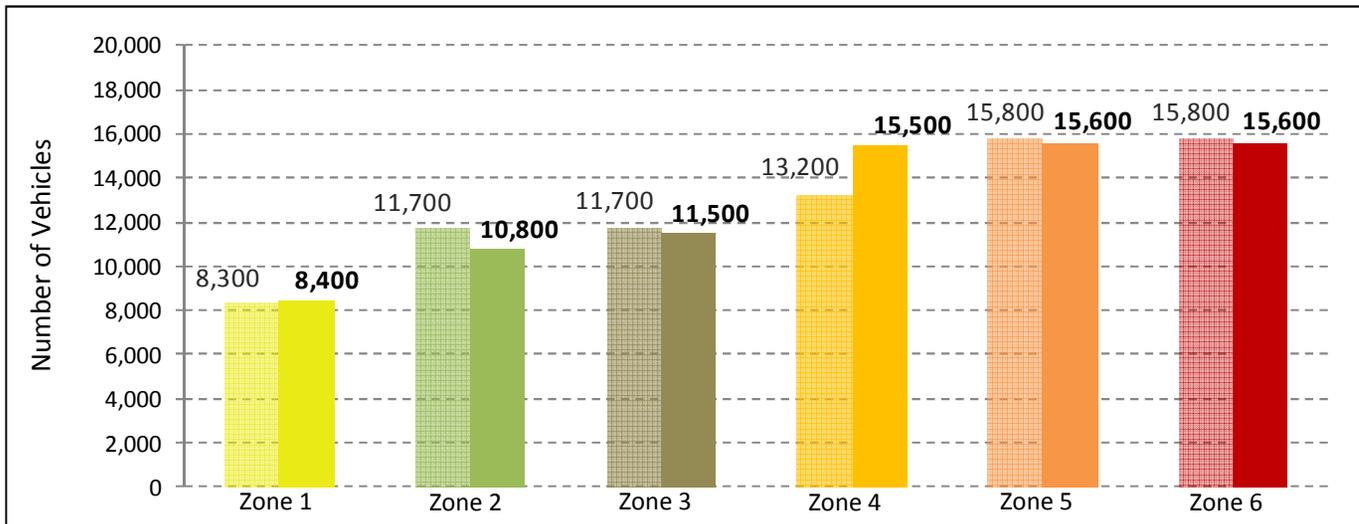
Figure 3.4

Comparison of average annual Daily Traffic: 2002 to 2011

Traffic volumes are heavier in the context zones closest to I-35. There has been a slight decrease in daily traffic over the past decade, with the exception of Zone 4, a residential area which has seen traffic increase by more than 2,000 cars per day.

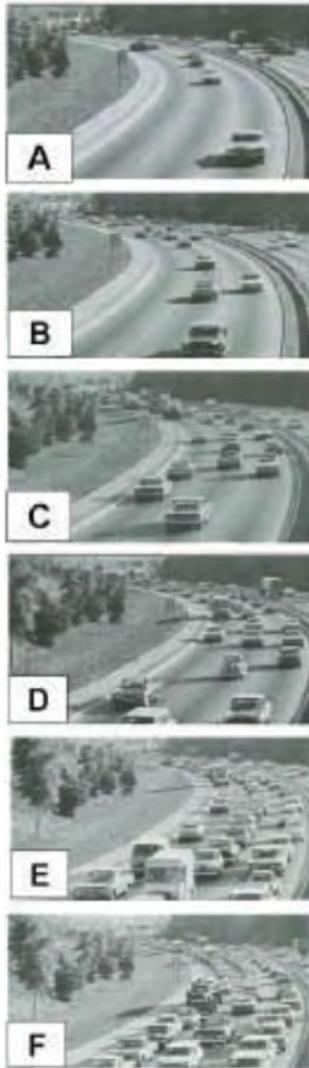
Figure 3.5 | Vehicle level of service (LOS)

LOS is a qualitative statement about the road's operation (A-F), but is based more quantitatively on the measure of number of vehicles present compared to a road's capacity.

Despite a trend towards flattening VMT, future development is expected along the Highway 23 corridor. The impacts of this growth on the traffic capacity of the roadway are projected to be significant but still remain better than an LOS D (see Figure 3.5). During this study, the traffic

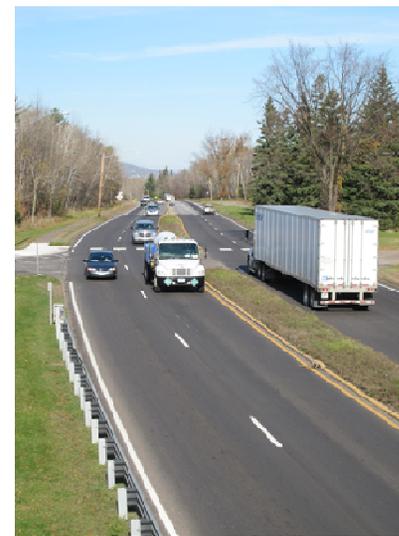
Figure 3.6 | Heavy truck traffic

Heavy trucks make up approximately 4% of the daily traffic in the Highway 23 / Grand Avenue corridor. But there are hours during the mid-day, when trucks represent a significantly greater percentage of the traffic.

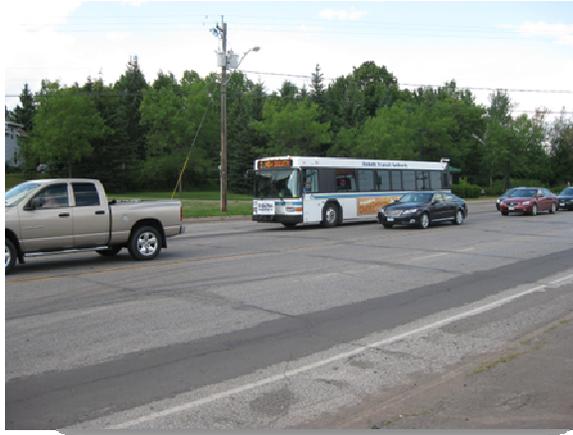
Figure 3.7 | DTA bus service along Highway 23

The Highway 23 / Grand Avenue corridor represents one of Duluth Transit Authority's (DTA) most utilized bus routes.

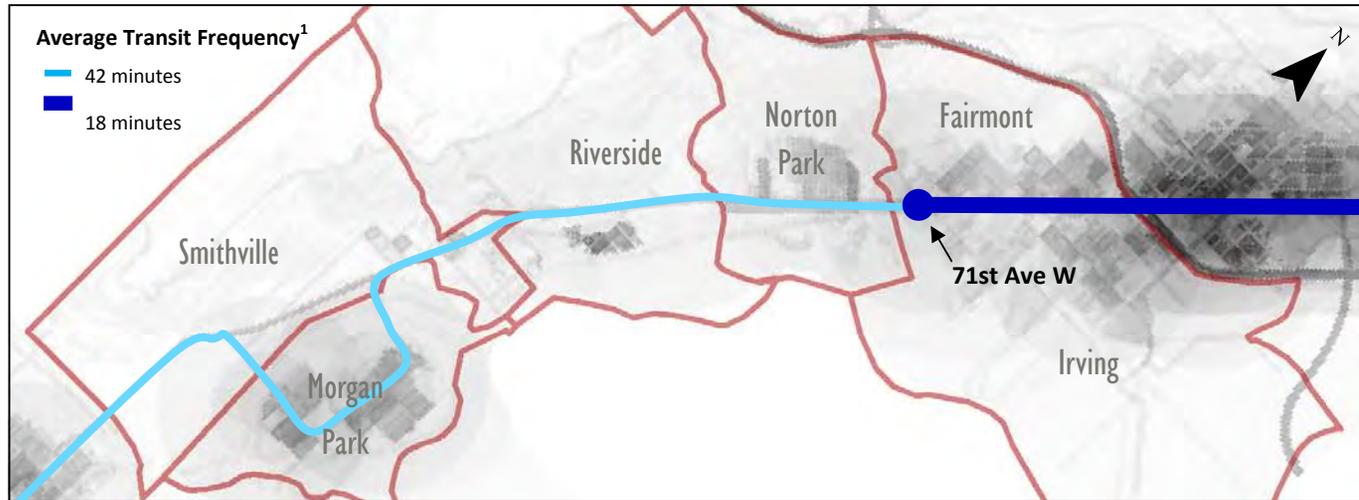
Map 3.3 | Transit frequency

The DTA runs three routes along Highway 23 south of I-35. The section of the highway north of the turnaround point at the zoo (71st Ave W) has buses running approximately every 18 minutes, while the majority of the corridor has buses passing through every 45 -minutes, on average.

The pattern of transit frequency appears to complement the patterns of residential density (depicted in black on maps 3.3 and 3.4) that are found in the neighborhoods along the highway corridor. With that said, even though buses run less frequently southwest of the zoo, there are still bus stops in that part of the corridor that produce daily ridership levels comparable to the stops northeast of the zoo that get have more frequent transit service. This is shown in Map 3.4 on page 29 and begs the question as to whether transit service under its current configuration is sufficiently meeting demand within that section of the corridor. Although the MIC received no comments to that effect received from the stakeholder engagement during this study, it should be noted that transit riders were not specifically surveyed along the corridor, and thus some further assessment of this on the part of the DTA may be warranted.

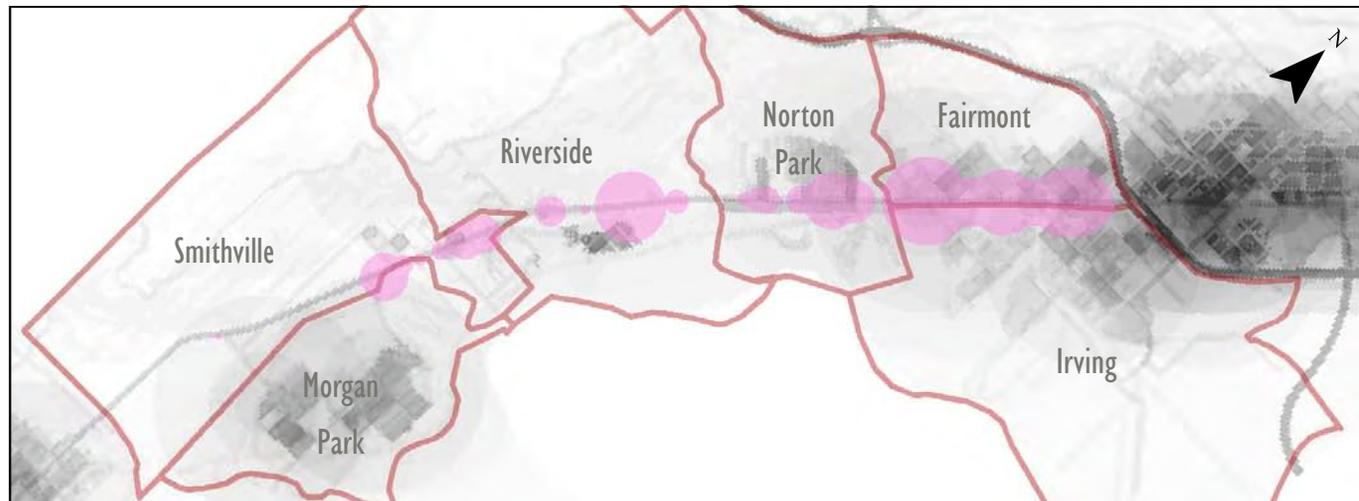
Map 3.4

Daily transit boardings & alightings

The majority of transit ridership along Highway 23 comes from the more densely populated area near I-35 (area shown in black). Some transit stops further south, however, also generate large numbers of riders.

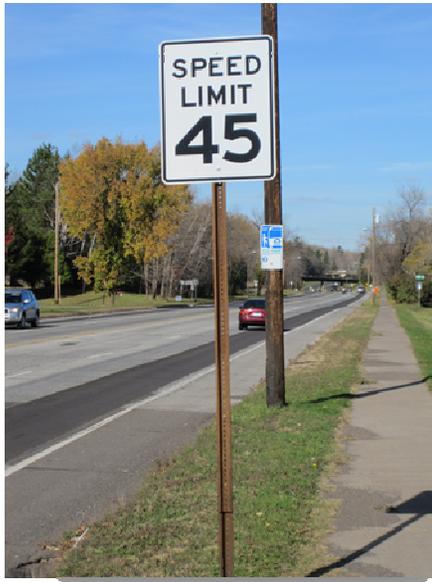
Figure 3.8 | Posted speed limit in Zone 1

The more rural sections of the Highway 23 corridor are posted for a speed limit of 45 mph. The average free-flow speed in these areas, however, is believed to be above 50 mph, due largely to the wide and normally non-congested roadway.

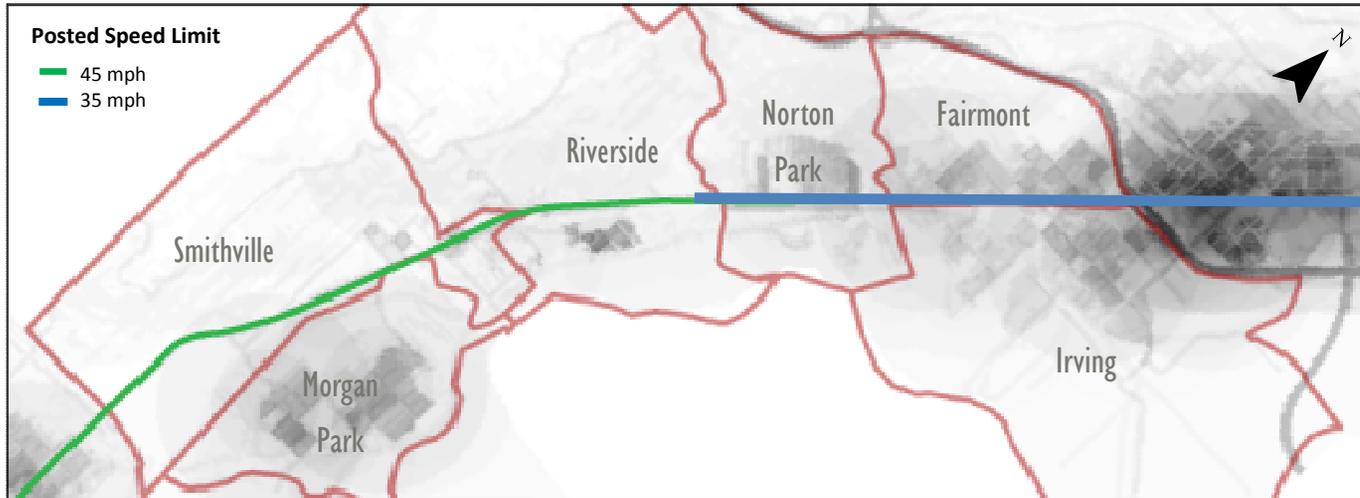
Map 3.5

Posted speeds on Highway 23

The highway is posted for 35 mph in the more densely populated, urban half of the corridor. The speed limit increases to 45 mph west of the neighborhood of Norton Park.

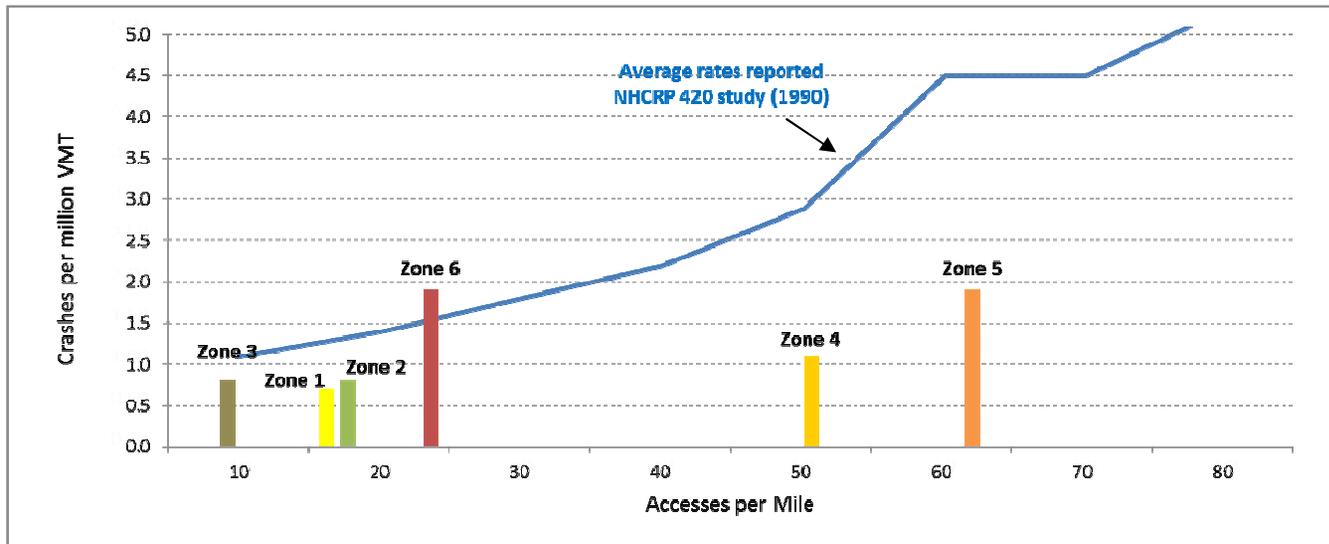
Figure 3.9
Crash rate and access density comparisons

Although none of the context zones studied had crash rates that exceeded the area average, the rates in Zone 6 did exceed what research has indicated to be typical in terms of the densities of intersections and driveways that are found in that zone.

the densities of intersections and driveways found in that segment (see Figure 3.9 on page 32). This is discussed in further detail on pages 66 and 67, which address conditions specific to that context zone.

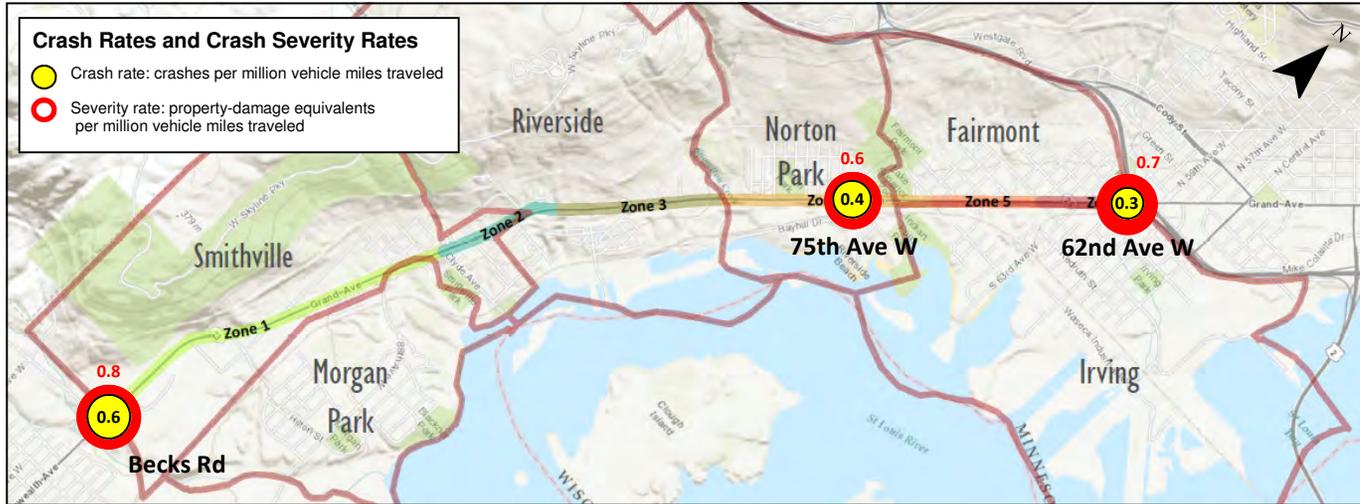
Map 3.6

Locations of intersections with above average crash rates

The map at right shows the three intersections in the study area that have had a 3-year average crash rate (yellow dot) that, since 2009, that exceeded the regional average for similar roadways. It is important to note that 62nd Ave E has a higher disparity between its crash rate and its severity rate (red circle).

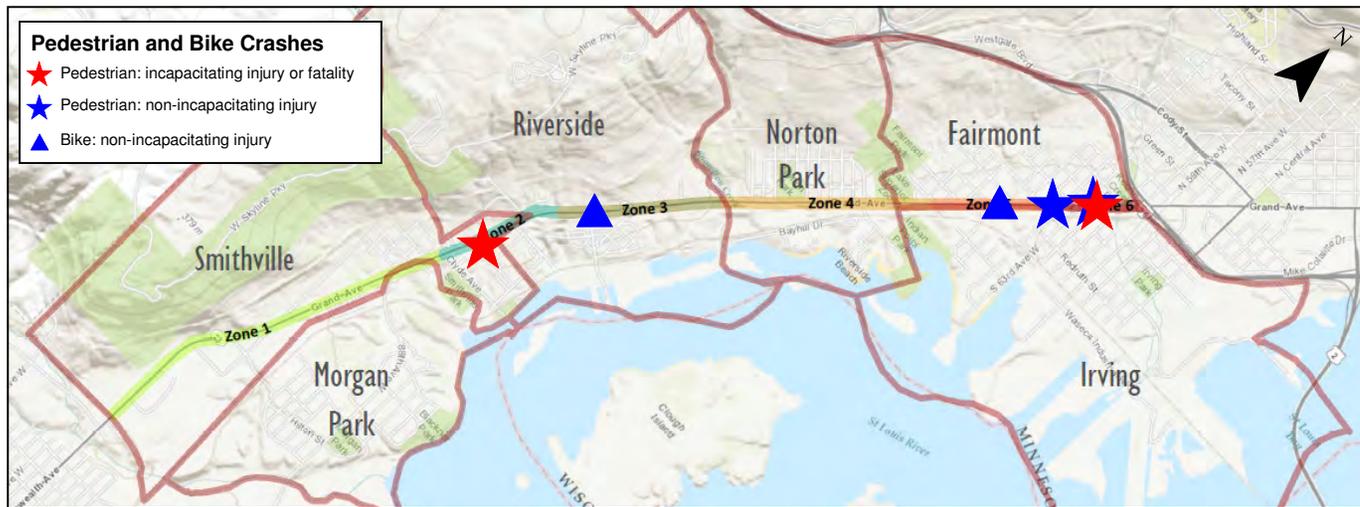
Map 3.7

Bike & pedestrian crashes from 2003 to 2012

Four pedestrian crashes and two bike crashes occurred in the Highway 23 corridor over the past decade. The pedestrian crashes that resulted in a fatality and incapacitating injury happened in areas where vehicle speeds and potential visibility limitations are concerns.

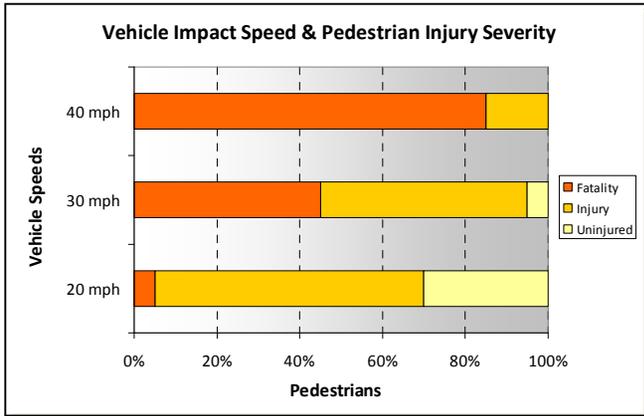
Figure 3.10 | Vehicle impact speed & Severity of Injury

Research shows that pedestrians being struck by vehicles traveling at or above 40 mph face an 85% probability of being killed.

Vehicle speeds are critical when it comes to the safety of non-motorized users of a highway corridor. As Figure 3.10 demonstrates, there is more than a 40% probability a pedestrian will be killed if struck by a vehicle traveling at even just 30mph. This means that Highway 23, with average free-flow speeds estimated to be above 38mph, represents a significant challenge for maintaining a safe environment for non-motorists.

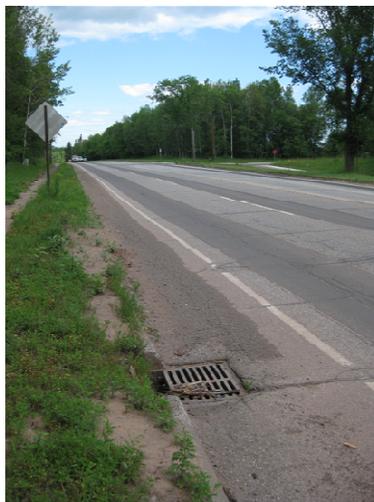
Figure 3.11 | Poor support for non-motorized users

The Highway 23 corridor is replete with conditions that do not support pedestrian or bicycle safety. The image to the left shows a location in Zone 2 where the sidewalk is crumbling and overgrown and the storm water grates present hazards for bike tires in an already narrow shoulder.

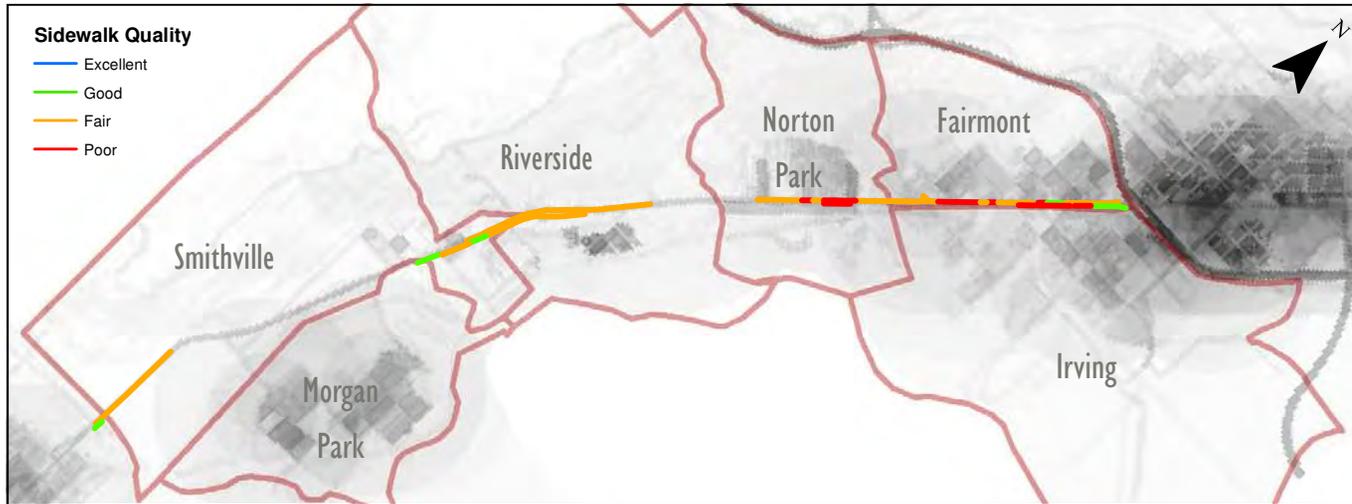
Sidewalk and sidewalk condition

Approximately 1/3 of the corridor has no sidewalk on either side of the highway. A significant amount of the sidewalk in the more densely populated Fairmont and Irving neighborhoods is in poor condition.

ways feasible. This includes making sure that the sidewalk network is complete and adequately maintained, that safe space is made available for cyclists, and that adequate lighting, visibility, and the necessary signage is provided. Figure 3.11 on page 34 and Map 3.8 on page 35 show how this is presently not the case in terms of the existing sidewalk network along the highway. The map, in fact, indicates that the sidewalks in the worst condition are found in the densest residential zones.

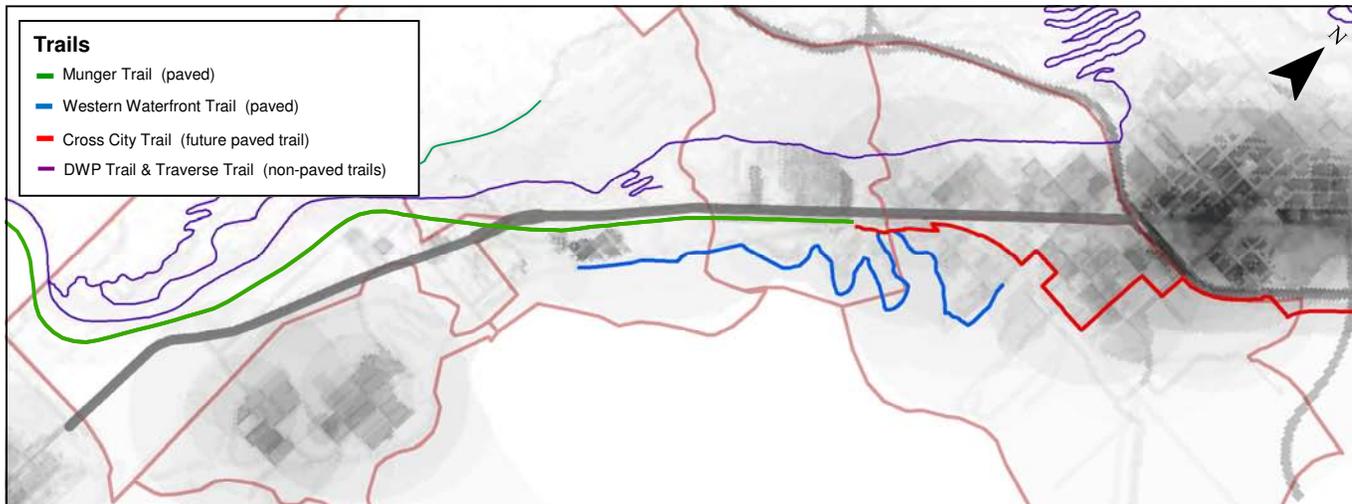
Map 3.9

Trail connectivity

The area of West Duluth surrounding the Highway 23 corridor contains a lot of trail amenities and potential non-motorized alternatives to the highway. But these assets lack good connectivity to the highway and the neighborhoods.

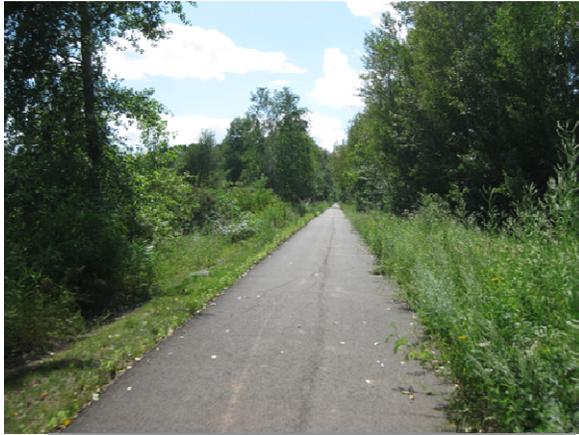
Figure 3.12 | The Munger Trail

The Munger Trail is a regional recreation trail that does not provide a lot of connections to local land uses and therefore does not serve the needs of many local bicycle commuters.

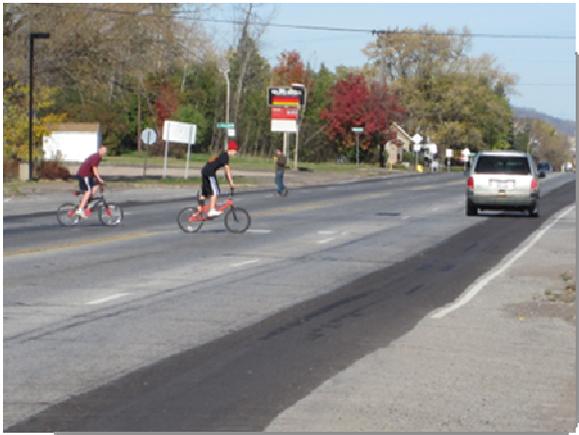
Figure 3.13 | Non-motorized crossings

There is significant non-motorized demand in the areas around Highway 23, but crossing the highway presents the biggest challenge for non-motorized travel in the corridor.

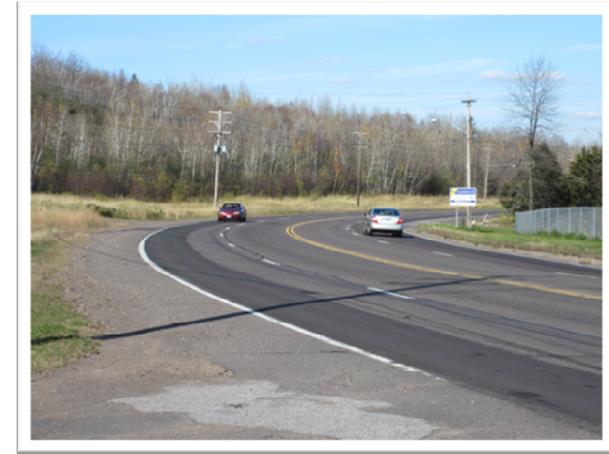
Figure 3.14 | Rural-design shoulder found in Zone 1
More than half of the length of highway 23 in Zone 1 is “rural” in design, meaning lacks sidewalk and curb and gutter.

Zone 1 is the least developed segment of the Grand Ave / Highway 23 corridor and carries the least amount of daily traffic compared to the other zones. Almost 63% of the highway in this zone is designed as a rural highway section (from Commonwealth Ave to Hulett Ave), meaning it lacks sidewalks, curb, and gutter. The roadway instead has wide, gravel shoulders like the ones seen in Figure 3.14 at right.

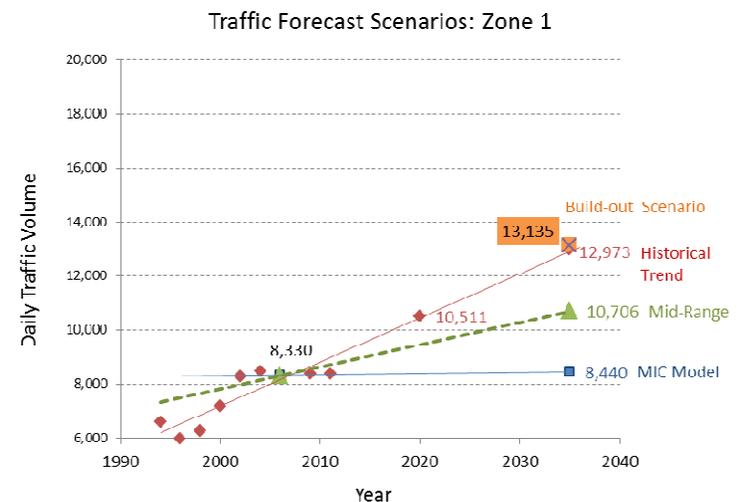
Figure 3.15 | Future Traffic Scenarios for Zone 1

A future build out scenario of zoned industrial areas near Becks Rd suggests the potential for nearly 6,000 more vehicles per day in Zone 1. See Appendix A for explanation of forecasting methodology.
