DTA Transit Shelter Audit/Inventory

May, 2017 TAC & MIC Policy Board Meetings

The Idea

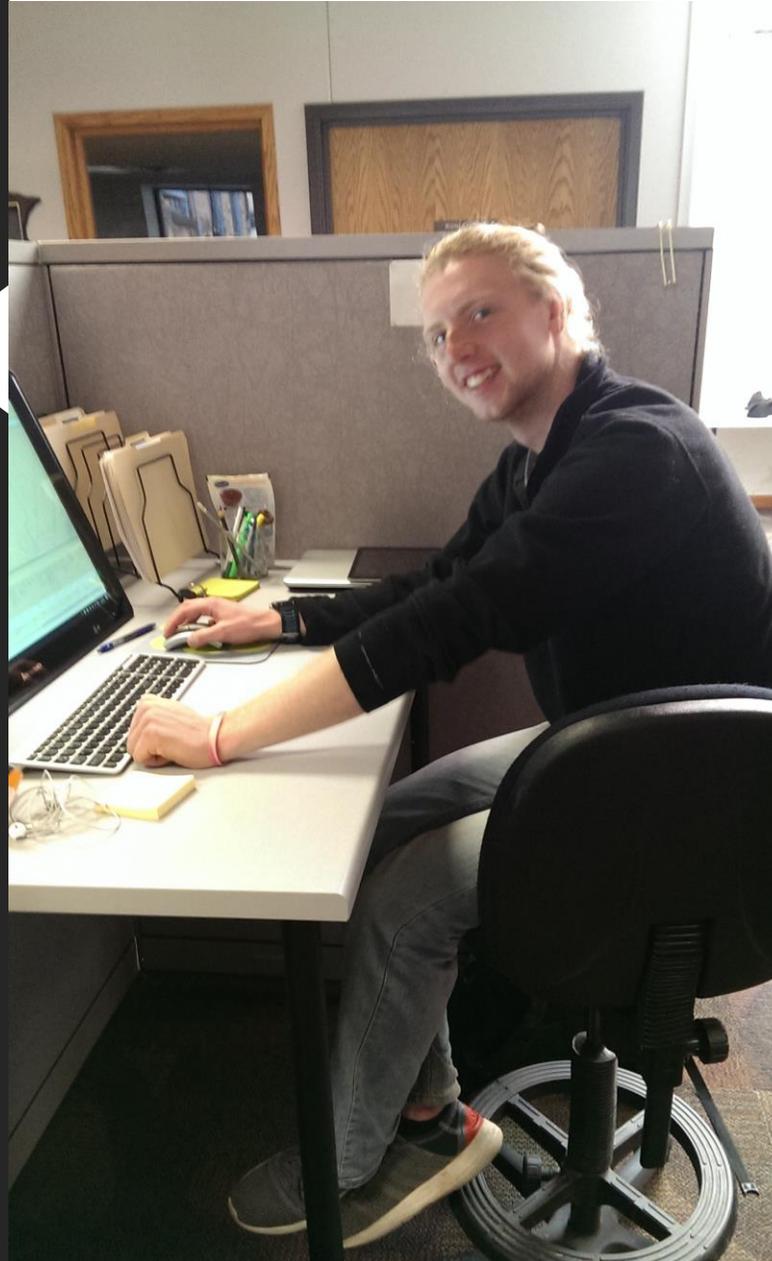
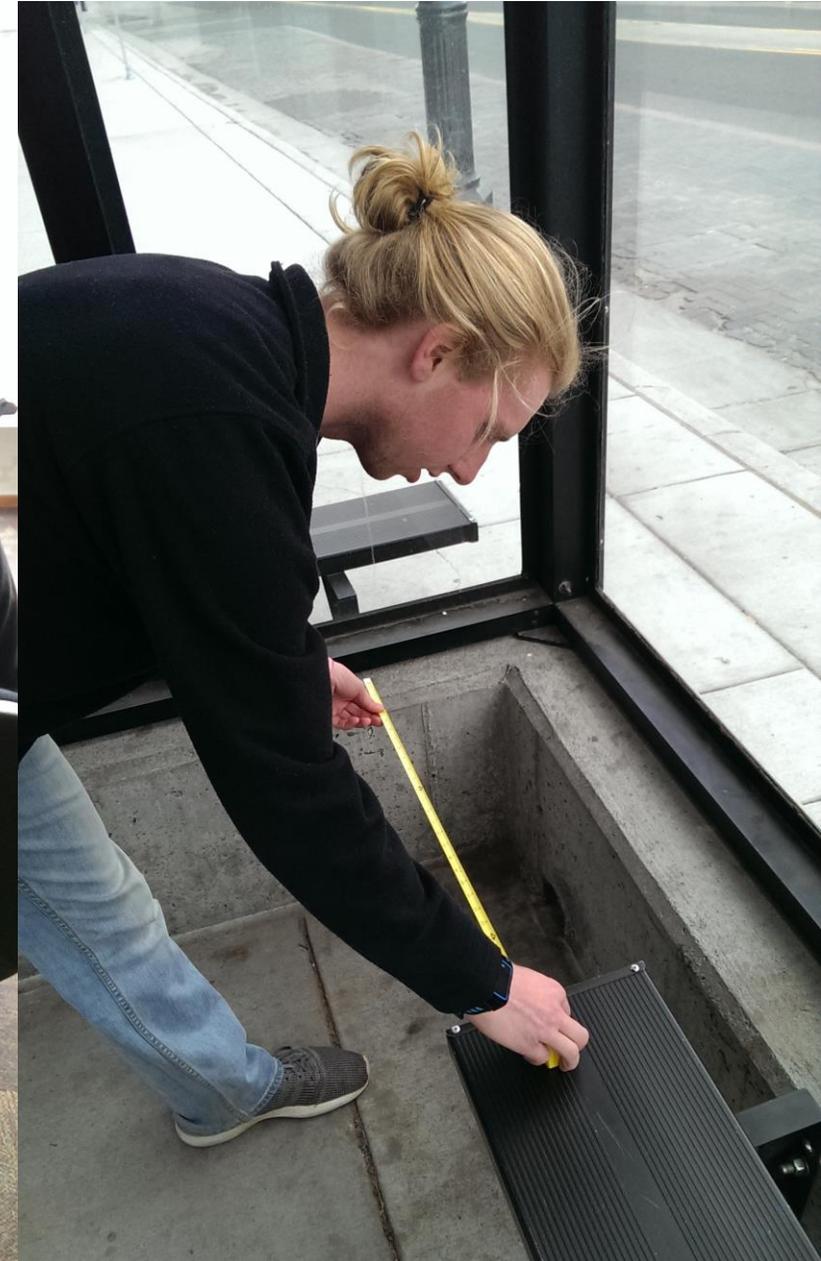
Bus Shelter: Kirby Dr & Kirby Plaza

Latitude	46.82
Longitude	-92.09
Cross streets	Kirby Dr & Kirby Plaza
Travel direction fro DTC	Outbound
Instellation year	0
Owner	DTA
Is it active?	YES
Is there a trash bin?	Yes
What type of seating area is there?	Half bench
What type of lighting is present?	Lighting located around stop
Is there bike parking?	Yes
Is the bus stop sign within 10ft of the shelter?	No sign
Is there room for the bus to pullout from traffic parallel to curb?	Yes
Are there green features or is there landscaping?	Yes
What size of landing pad is there at the shelter?	Bus size
Is there an obstruction to the line of sight?	No
Is the bus stop area signed 'No Parking'?	Yes
Is there a physical barrier between rider and traffic?	No
What type of schedule signage is there?	Dynamic
How much of the shelter walls are transparent?	Fully Transparent
What street crossing features are there?	Crosswalk
How does the shelter connect to sidewalks?	Both sides

Does the landing pad cover the boulevard?	Yes
Does the bus stop share space with another street use?	No
What part of the block is the stop located on?	Mid-block
Is there a pull out bay for the bus?	Yes
Is there a system or route map displayed?	No
How is the shelter oriented to the roadway?	Building side, open to curb
Is the shelter in the right of way?	No
Back support is present and, at minimum, 42" long (903.4)	Yes
Back support is no more than 2.5" behind the back of the seating surface (903.4)	Yes
Back support must fall within a space 2" above the seating surface to 18" above (903.4)	Yes
If mounted in an unprotected location, seating surface is slip resistant and doesn't accumulate water (903.7)	Yes
Benches are a minimum 42" in length (903.3)	Yes
Benches are between 20" to 24" deep (903.4)	No
Seat height is between 17" and 19" from the ground (903.5)	Yes
Ground and floor spaces of stop and shelter are firm and stable (810.2.1)	Yes

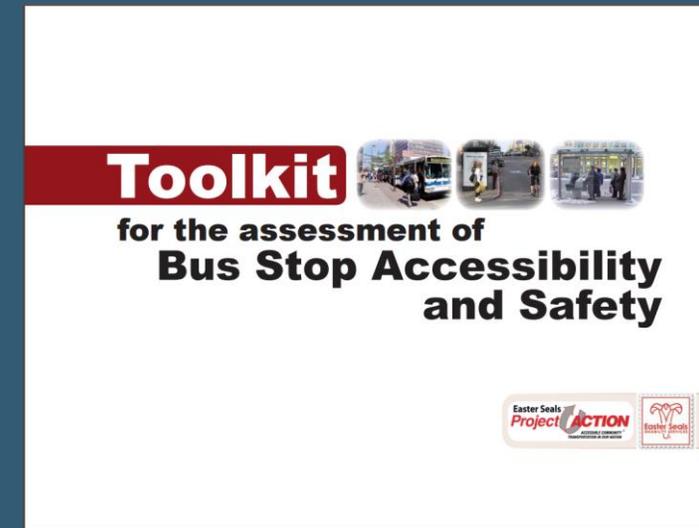
The floor around the stop and in the shelter don't have openings that would allow passage to a ½" or greater sphere (302.3)	Yes
Walking surfaces of stop area have no more than a 1:20 slope (402.2 & 403.3)	Yes
