## 7. Active Transportation

## Sidewalk Network

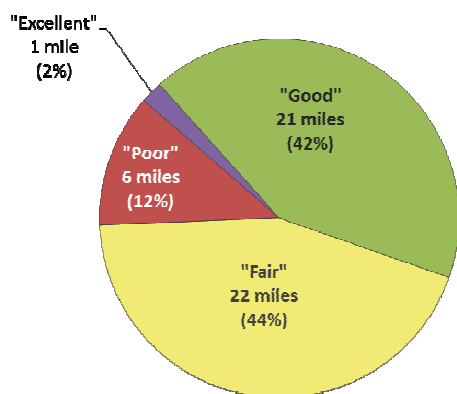
**Figure 7.3 | Condition of sidewalks in the Lincoln Park neighborhood**

There is a good balance of sidewalk conditions in the Lincoln Park neighborhood. Only 12% of the sidewalks are in poor condition.

There are more miles of sidewalk in “Good” or “Fair” condition (86%) than there are in “Poor” condition (12%) in the Lincoln Park neighborhood (see Figure 7.3 below). Overall, this is a decent balance of asset condition, but when looking at the specific locations where the poor sidewalk exists, some accessibility concerns arise. It is worth noting in Figure 7.2 on the previous page that a number of sidewalk segments in disrepair in the neighborhood (the segments in red) also exist in the areas with the greatest pedestrian demand.

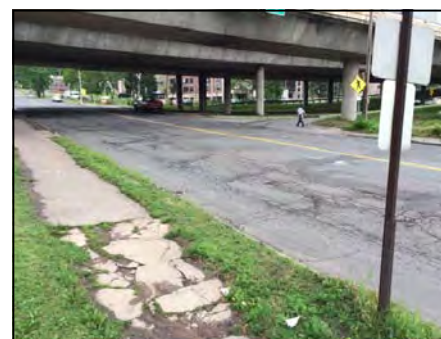
**Figure 7.4 | Sidewalk in poor condition along 21st Avenue W**

Much of the sidewalk that is in poor condition in the Lincoln Park neighborhood has uneven surfaces, making it hard for those with ambulatory difficulties to travel along them.

Sidewalks in poor condition tend to result in uneven surfaces (see Figure 7.4) that can be challenging for people with ambulatory difficulties, such as many senior citizens and those with physical disabilities. Those challenges can be exaggerated when they exist on sidewalk that traverses slopes, such as found on a number of avenues in the Lincoln Park neighborhood.

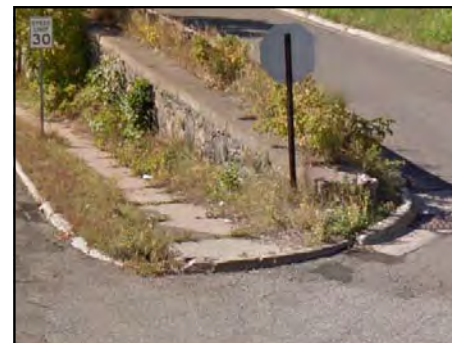
**Figure 7.6 | Non-ADA compliant sidewalk at Piedmont Avenue & W 2nd Street**

A number of sidewalks in poor condition in the Lincoln Park neighborhood were also observed to lack ADA compliant curb ramps.

*Pedestrian connections in the central business district:* The area with perhaps the greatest pedestrian demand in Lincoln Park is in and around the neighborhood’s CBD. Yet, that area also has some of the greatest concentration of sidewalk in poor condition (see Map 7.3). There is a concentration of low-income households just north of the CBD, who travel south to access both the DTA transit shelters as well as the businesses in the area. It is recommended that these sidewalk segments be prioritized both for repairs but also upgraded curb ramps (Figure 7.6) in order to make the sidewalks in one of the busiest areas

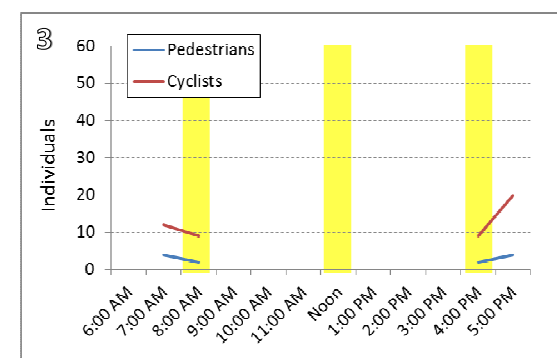
**Figure 7.11 | Comparison of east- and westbound bike and pedestrian traffic on Michigan Street at Superior Street (July 9, 2013)**

2-hour bike and pedestrian counts were conducted in the AM and PM just east of the intersection in July of 2013. Bike traffic was observed at 4 times the level of pedestrian traffic.

It can also be seen from the count data at the three locations that the patterns of bike traffic do not directly coincide with those of motorists or pedestrians. Peaks in the volumes of cyclists differ relative to the AM, noon, and PM hour peaks of motor vehicles (noted by the yellow bars in the graphs).

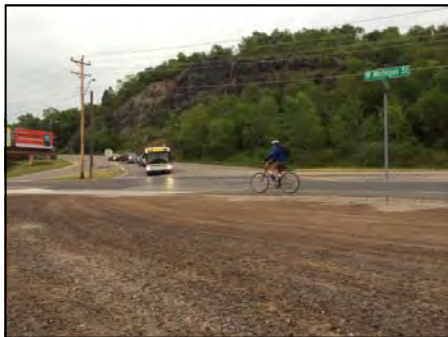
**Figure 7.12 |**  
**Cyclist at the intersection of Superior Street & Lower Michigan Street**

The intersection below the “Point of Rocks” is the only “flat” route for cyclists to travel between downtown and West Duluth. It is believed that the intersection gets a lot of bike traffic for this reason.

The counts done on Superior Street at 27<sup>th</sup> Avenue W and on W 3<sup>rd</sup> Street at Carlton Street were conducted for 12 hours. They showed bike traffic to be around 75% of the amount of pedestrian traffic at those locations. The counts done on Superior Street near its split with Lower Michigan Street were, in contrast, only taken during the AM and PM peak hours, but indicated that substantially more bike traffic occurs there - a likely reflection of the challenging topography in that area. Traffic is funneled to Superior Street to get around the “Point of Rocks,” and the alternative routes of W 1<sup>st</sup> Street and W 3<sup>rd</sup> Street to the northeast follow a series of steep slopes that make cycling much more difficult (Figure 7.12).

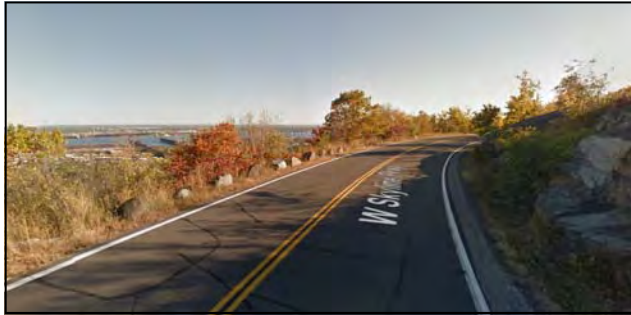
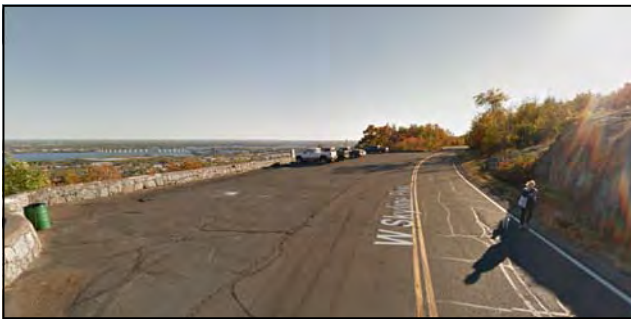
**Figure 7.13 | Street views of Skyline Parkway above the Lincoln Park neighborhood**

Skyline Parkway is a scenic route that draws active transportation users, as well as motorists. By narrowing the travel lanes and installing additional pavement markings and signage, the roadway could better support cyclists and pedestrians.

Skyline Parkway is a scenic route above the neighborhood that draws a lot of recreational pedestrian and bike traffic because of its majestic views of Lake Superior. These same views, however, also draw motorists. The 1.2 miles of Skyline Parkway between Haines Road and N 28th Avenue W is a narrow and windy roadway with very little shoulder space. Its dimensions vary according to location, but, on average, there is 26ft of pavement, with 13-foot wide travel lanes and a white fog line on the edge of the pavement (see Figure 7.13).

While there is not enough space to give pedestrians and cyclists a separate lane of pavement, a few things could be done. The travel lanes could be narrowed to 11 feet, which would give pedestrians and cyclists more room, but also have the effect of calming traffic speeds and making the roadway safer and more comfortable. The roadway may also be benefitted by the addition of sharrows (Figure 7.14) and high-visibility signage to notify motorists (especially visitors not familiar with the route) of the possibility of encountering cyclists or pedestrians around the bends.

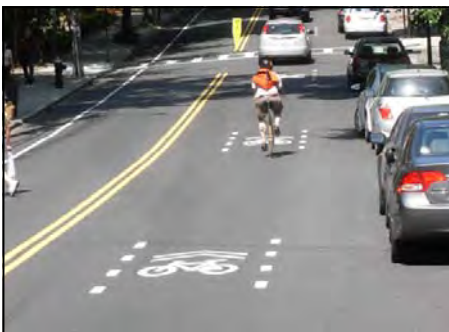
**Figure 7.14 | Example of a sharrow marking**

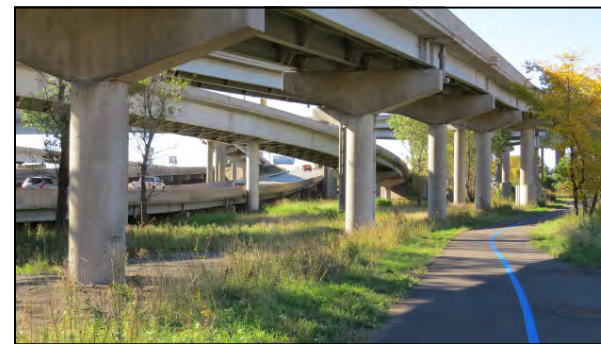
**Figure 7.15 | The Cross City Trail in Lincoln Park**

The Cross City Trail acts as a "trail highway", connecting the Lincoln Park neighborhood to the City of Duluth's Lakewalk to the Northeast and the Munger Trail to the southwest.

At the time this study was underway, 1.8 miles of Duluth's Cross City Trail had just been constructed through the southern two-thirds of the Lincoln Park study area (Figure 7.15). The trail links with the City's Lakewalk Trail in Canal Park, and about six more miles are planned to be added westward over the coming decade. Once completed, there will be a paved trail that runs the entire length of the City of Duluth. Conceptually, the result will be a "trail highway" that runs across the city and connects with spur trails to other neighborhoods and communities in the area.

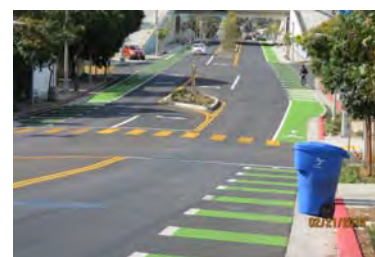
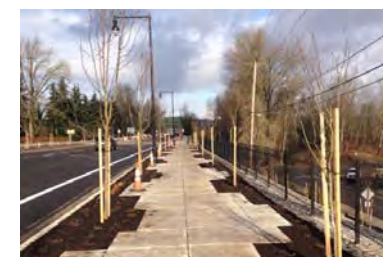
**Figure 7.17 | Street enhancement examples**

A variety of enhancements could be made to the segments of 26th Avenue W and W 3rd Street that connect with Lincoln Park Drive in order to highlight the street as an active transportation corridor.

As Map 7.8 shows, Lincoln Park Drive can serve as a connecting corridor between the Cross City Trail and Skyline Parkway. A big benefit of this connection is that it is essentially a greenway that runs through the neighborhood’s iconic central park. As a recreational corridor, however, the route could be better served with way-finding signage, as well as enhancements to the segments of 26<sup>th</sup> Avenue W and W 3<sup>rd</sup> Street between the park and the Cross City Trail at Superior Street (Figure 7.16). Enhancements to that segment could be as basic as marking the street pavement with a recreation lane and installing way-finding signs at its ends, but could also involve installing streetscaping elements to highlight the segment as unique corridor designated for active transportation users (see Figure 7.17 for examples).

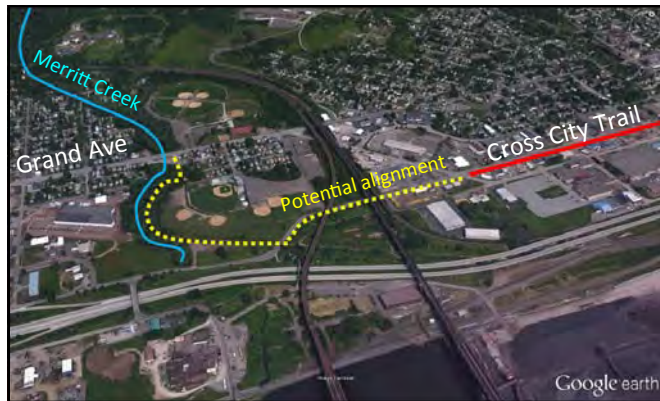
**Figure 7.18 | Conceptual corridor for a possible extension of the Cross City Trail along Merritt Creek**

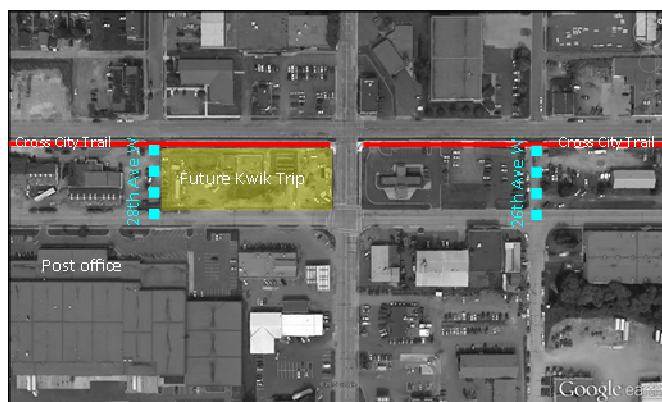
**Figure 7.20 | Conceptual pedestrian spaces at 26th Avenue W and 28th Avenue W**

Two other potential trail segments were identified at the avenues adjacent to the 27th Avenue W commercial node. At present, 26th Avenue W and 28th Avenue W do not extend below Superior Street. However, right-of-way for street potential street extensions do exist, and many pedestrians were observed moving through those areas during the study, presumably to avoid the busy intersections at 27th Avenue W (Figure 7.20). Because of the available right-of-way, these segments could be formalized as pedestrian spaces with paved trail connections and streetscaping amenities to encourage pedestrians and

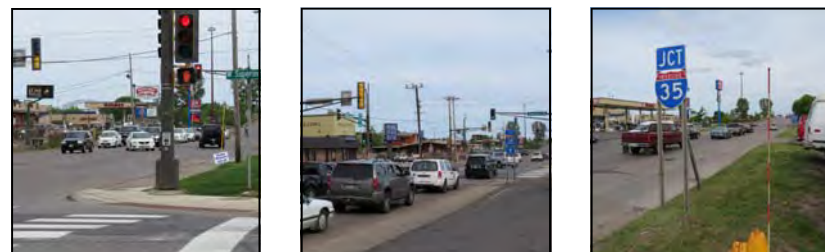
**Figure 8.3 | Current characteristics of the 27th Avenue W corridor**

Because of its close proximity to I-35 access and the concentration of commercial activities there, the segment of 27th Avenue W below W 1st Street generates a lot of traffic from all modes of transportation. The area will face operational challenges under future traffic growth. It is also poorly suited to bike and pedestrian movements.

One of the locations in Table 8.3 that should be given attention sooner rather than later is the segment of 27th Avenue W between W 3rd Street and Helm Street. Throughout this study, this segment has been shown to contain multiple concerns related to both safety and operations. It is also the most heavily trafficked segment of the neighborhood’s local street network, used heavily by all the modes studied. Furthermore, it links a growing commercial node to direct access to I-35. As this area has the potential to undergo rapid transformation, it would benefit local jurisdictions to try and influence the character and design of that transformation in ways that will enhance the integration of multiple modes, not create additional conflicts (Figure 8.3).

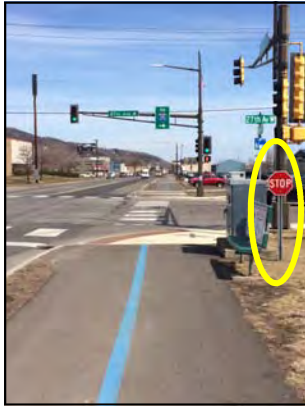
**Figure 8.4 | Cross City Trail at 27th Avenue W**

A very specific location of concern on the Cross City Trail is its intersection with 27th Avenue W. Small stop signs were installed along the trail to direct cyclists to stop at each intersection with a street, and those sign were likewise installed at 27th Avenue W (Figure 8.4). That intersection, however, has a traffic signal, which implies a different order of traffic operations. It is recommended that the stop signs be removed at that location and replaced with signal heads specific to cyclists on the trail (Figure 8.5) designed to the specifications - and accompanied with pavement markings - as recommended by the National Association of City Transportation Officials (NACTO) (see Figure 8.6). In addition, the signal operations at 27th Avenue W should be re-timed to give a protected phase to the cyclists in order to

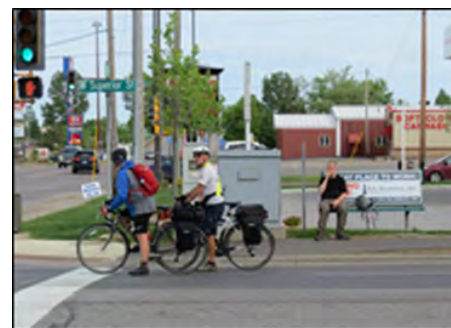
**Figure 8.7 | Bus stop at 27th Avenue W**

Other potential issues of poor integration along the Cross City Trail exist where there are transit stops for the DTA buses. At present, trail users and people waiting for buses have to share the same surface (see Figure 8.7), which could lead to conflicts if a significant group of riders are congregating at a specific stop. It is recommended that the DTA work with city Planning and Engineering departments to identify the busiest stops along the trail and seek opportunities to install separate, off-trail waiting areas for the transit riders at those locations (see Figure 8.7 as a potential example).

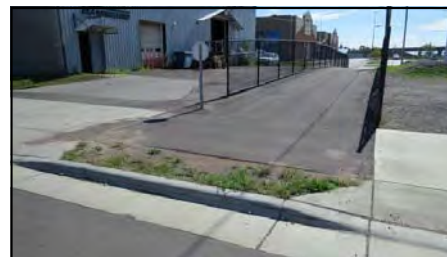
The spur trail at 30th Avenue W ends in a curb at Superior Street, which is not ideal for cyclists.

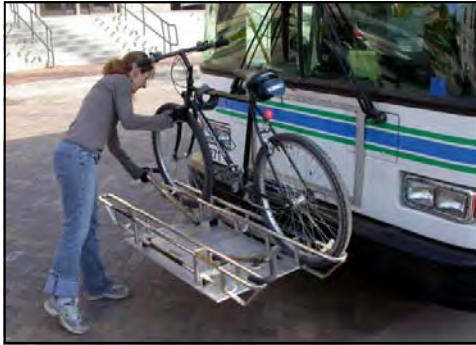
**Figure 8.10 |  
Bike racks on DTA buses**

Each DTA regular route bus is equipped with a bike rack.

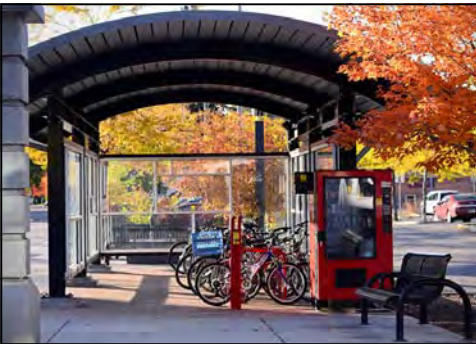
**Figure 8.11 |  
Bike parking at a bus stop**

The opportunity to link bus trips with bike trips can be enhanced by creating more bike parking opportunities near bus stops.

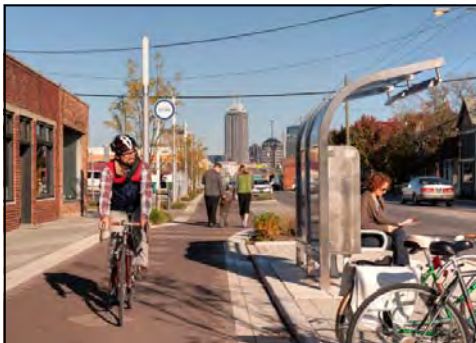
**Figure 8.12 |  
Pairing bus and bike facilities**
